Technical News of EFP Related Products

Subject	Notification of Failure 3803 Group H Specification Parallel Input-Output Mode			
Product	EF3803F-64F,EF3803F-64H,EF3803F-64U,EF3803F-64S,EF3803F-64B	Number	A05H24-02	
Object Lot	All Lots	Date	Aug.24,2005	Rev. B

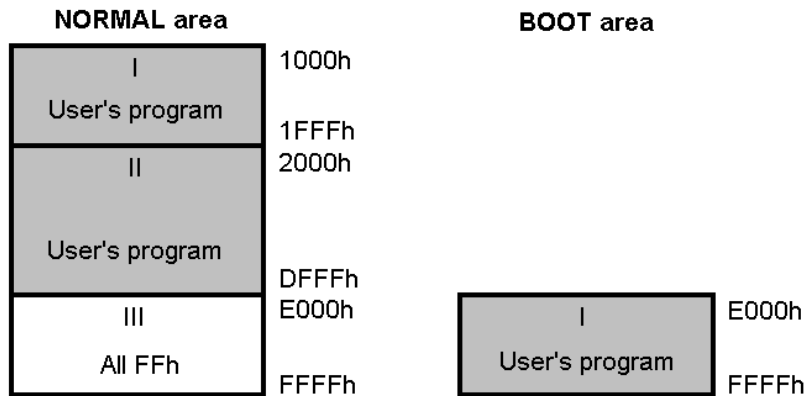
Though the area of the writer is set to be BOOT area (E000h ~ FFFFh), the execution area of the command shows NORMAL area (1000h ~ FFFFh). The area (1000h ~ DFFFh) which does not overlap is used for Normal area, however, the area (E000h ~ FFFFh) which overlaps is used for Boot area. It causes this failure.

After the failure occurs, if rewritten of all NORMAL areas is executed with E.B.P.V. macro command, etc., the following areas marked with will be rewritten.

This error can be fixed by upgrading Writer control software WinEfpRE.

*Error correction version is WinEfpRE Ver.1.30.05 or above.
